# Global Property Inspections Group

## Home Inspection Report

**840 NW 122 Street North Miami FL 33168**

Inspected on Thu, May 12 2022 at 12:00 PM

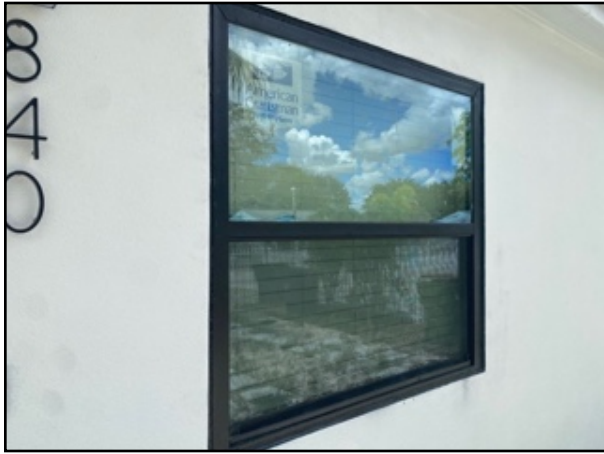
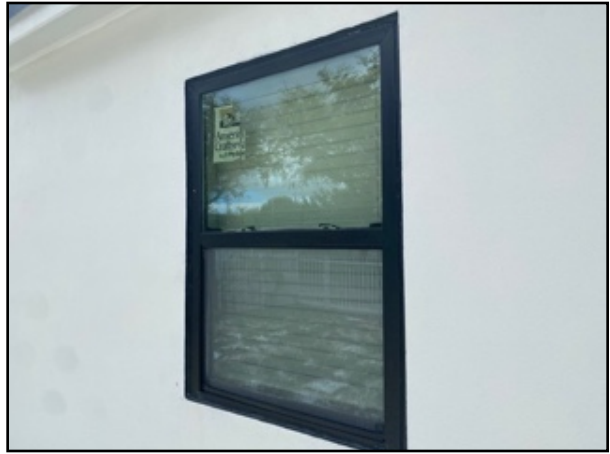
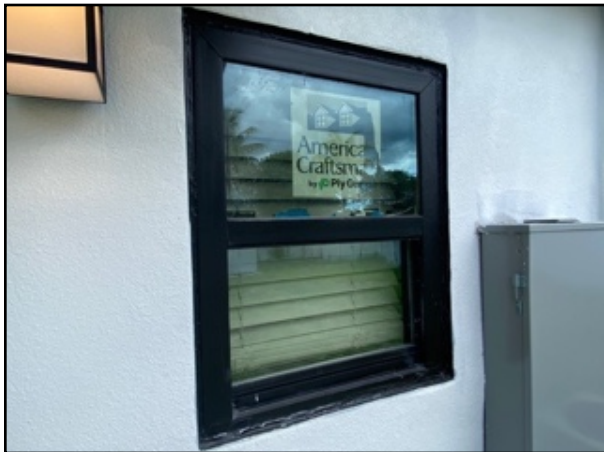
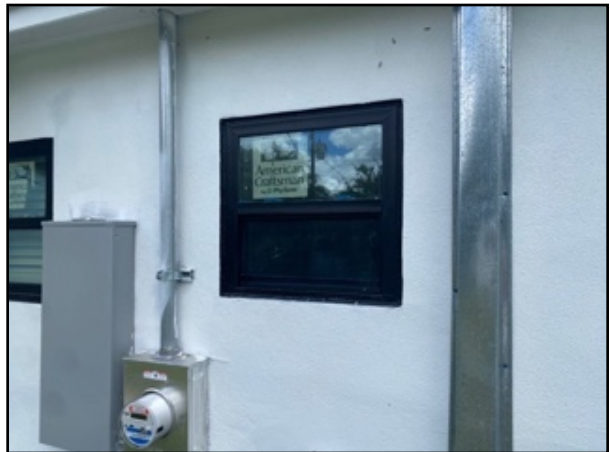
All windows are impact rated Miami Dade County approved products.

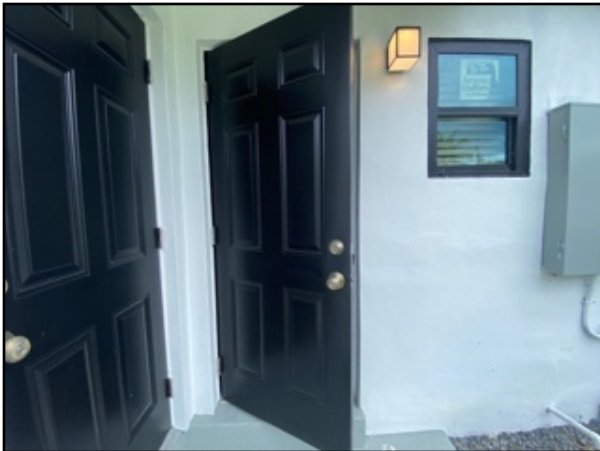
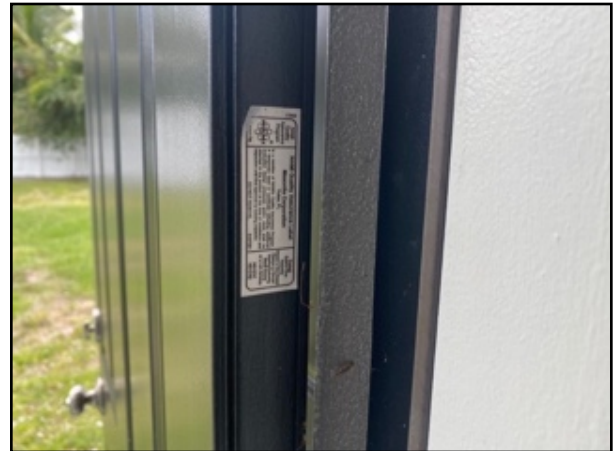
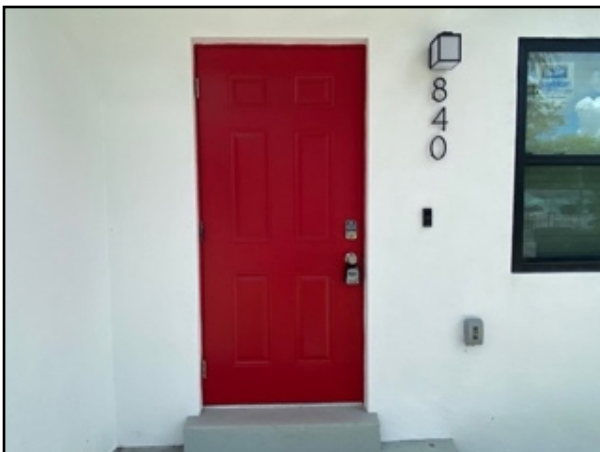
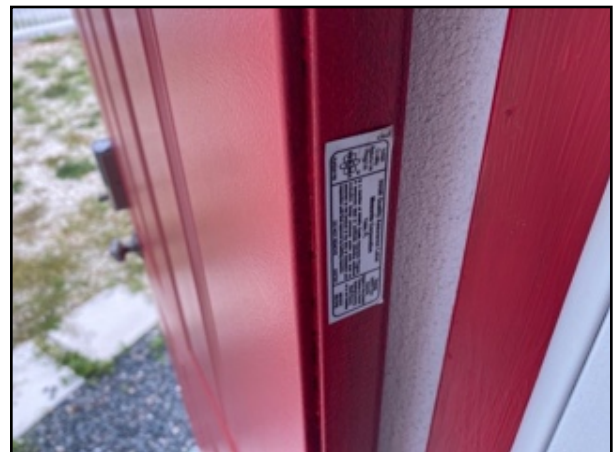
Both entry doors were functional at time of inspection. Doors has been identified as MDCA

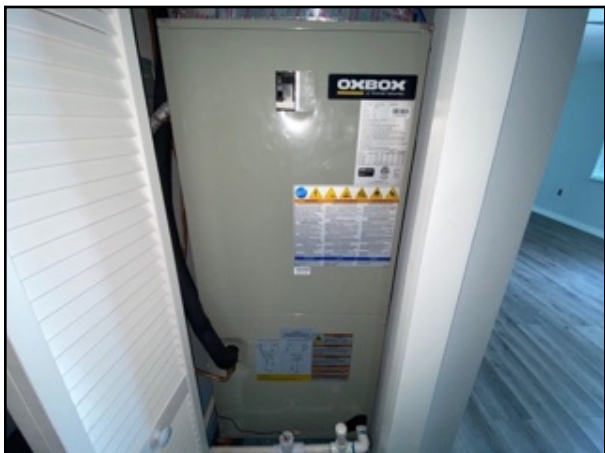
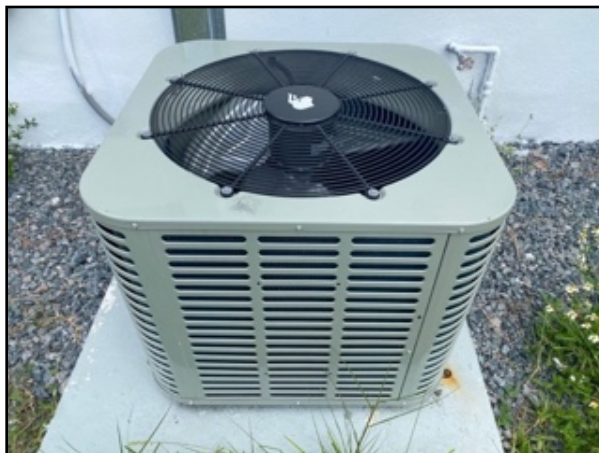
Both A/C Units were properly functioning at time of inspection.
