Cityhouse M Inc

840 NW 122 Street North Miami, FL 33168

## 4 Point Inspection

# 4-Point Inspection Form

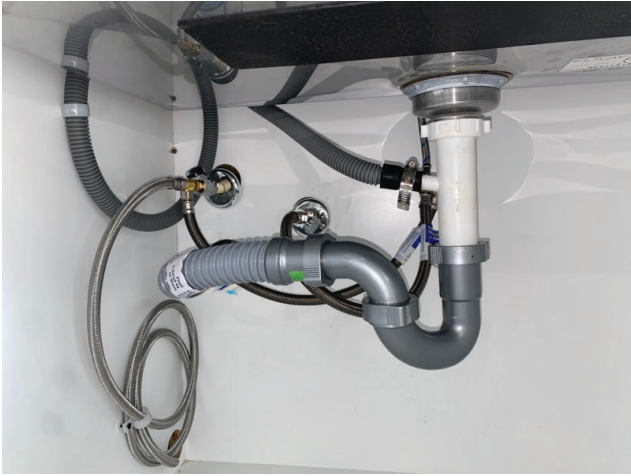
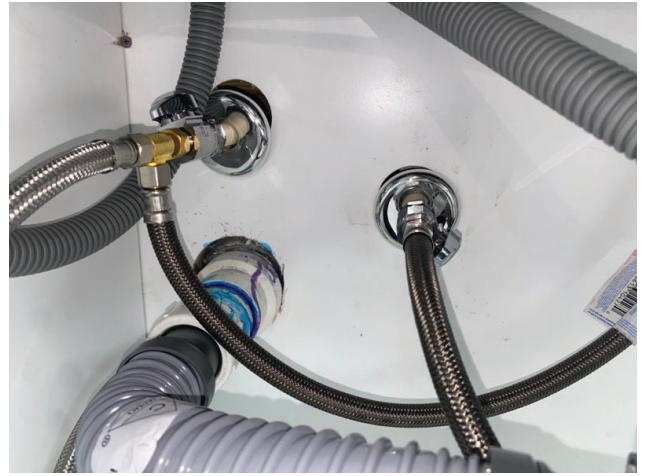
Kitchen plumbing component

Last plumbing update was done approximately in 2021 for bathrooms, kitchen fixtures and drainage have been replaced to pvc.

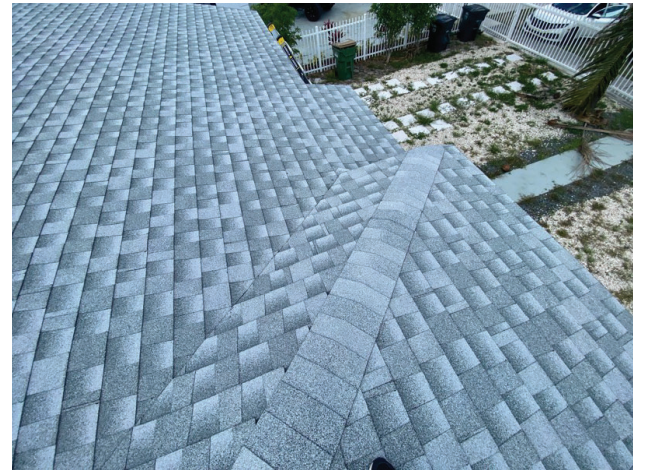
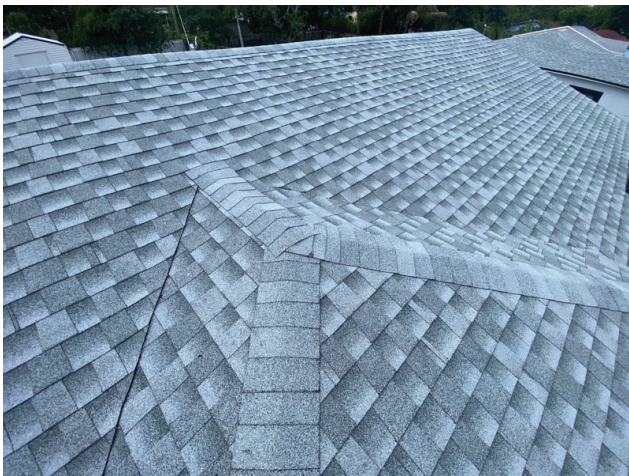
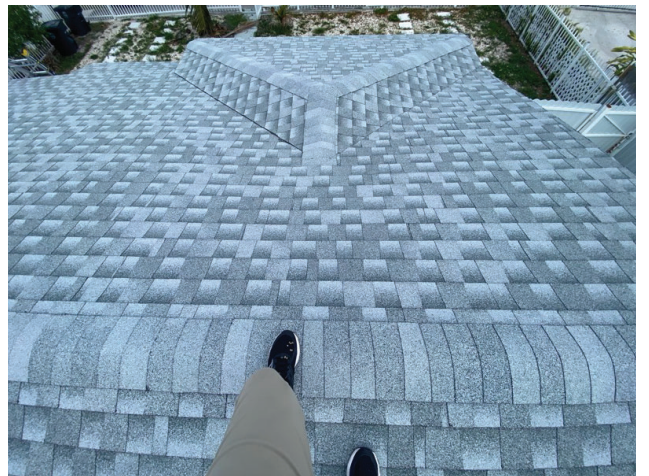
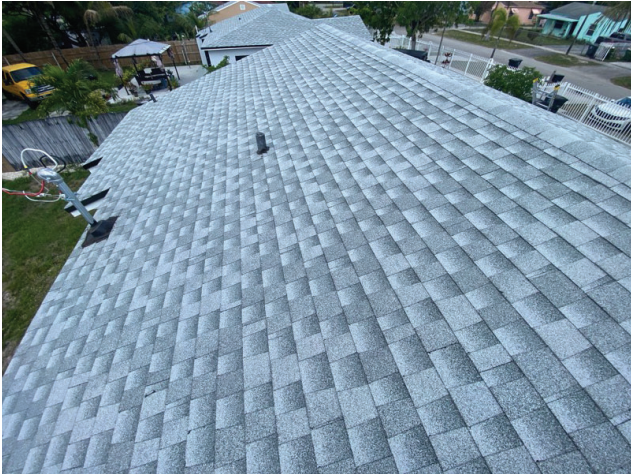
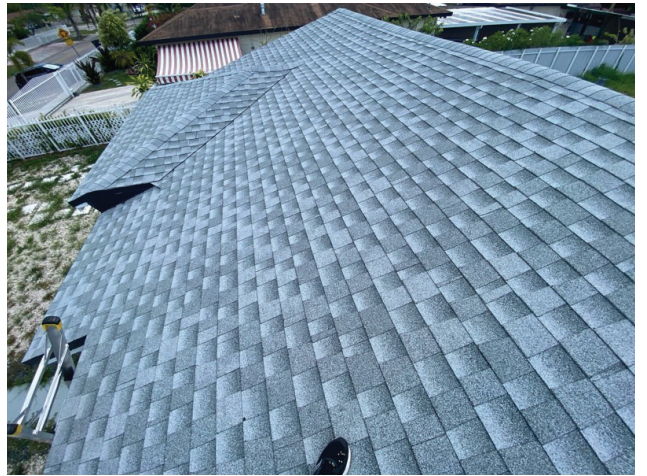
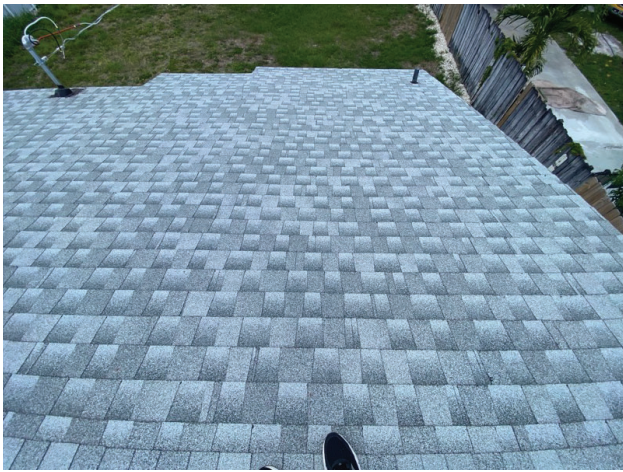
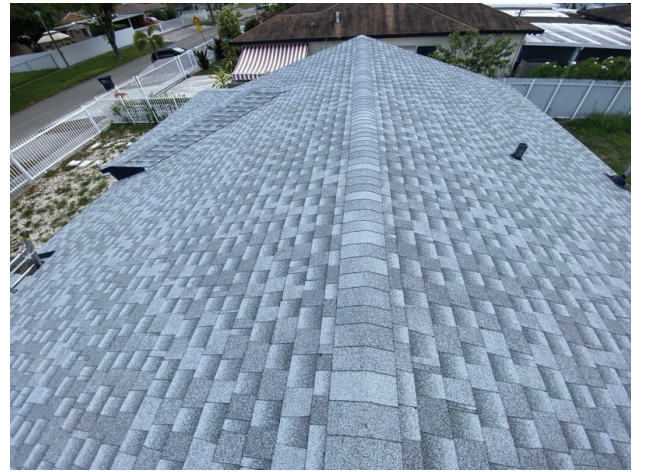
Asphalt shingle roof covering

Covering material: Asphalt shingle  
 Roof age (years): 2+/- years  
 Remaining useful life (years): 18+/-years (estimated)  
 Date of last roofing permit: 11/19/2020  
 Date of last update: 11/19/2020
